Manhole Inspection Summary

Manhole # S150O1012MH

Insp Date: **12/2/06 8:59 AM**

Location Address: **2504 RUSCOMBE LN**

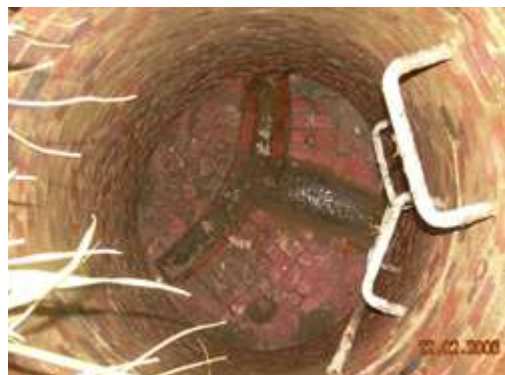
Top View

Adjustment and Corbel infiltration. Bench and Channel debris.

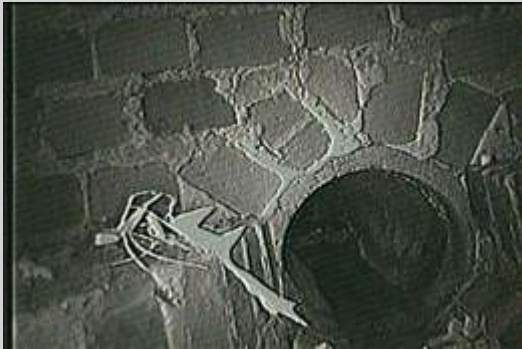
8 in. Circular Gravity Sewer Pipe Out @ 12 O'Clock

Pipe Material: **Clay** ☐ Pipe Lined

Invert Depth: **8.44** (ft.) Flow Characteristics: **Slow**

Infiltration: **None** Pipe Seal Cond: **Unknown**

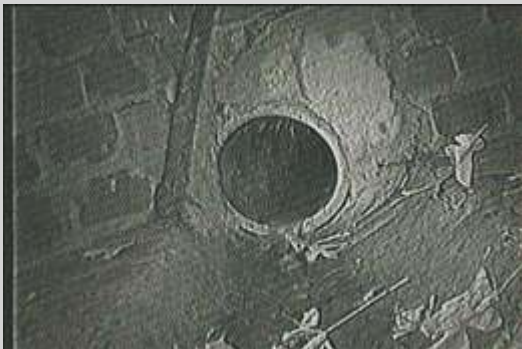
6 in. Circular Gravity Sewer Pipe In @ 4 O'Clock

Barrel cracks and infiltration.

Infiltration: **Evidence** Pipe Seal Cond: **Cracked**

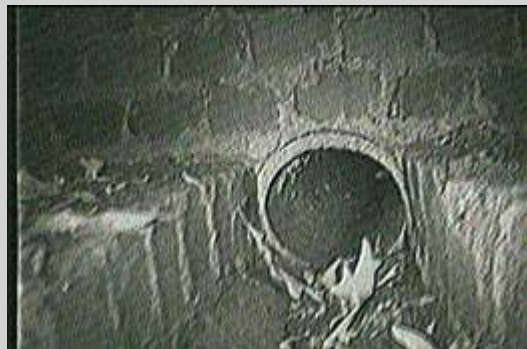
6 in. Circular Gravity Sewer

Infiltration: **Evidence**
